# Manhole Inspection Summary

Manhole # S19Y\_\_030MH

**Location** Address: **2521 washington bd**

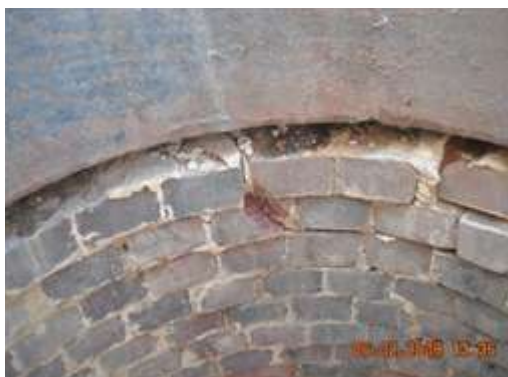
Defect 2

Condition: ☐ Sound ☒ **Cracked** ☐ Root Intrusion ☐ Loose Brick ☒ **Deteriorated**

cracked corbel bricks

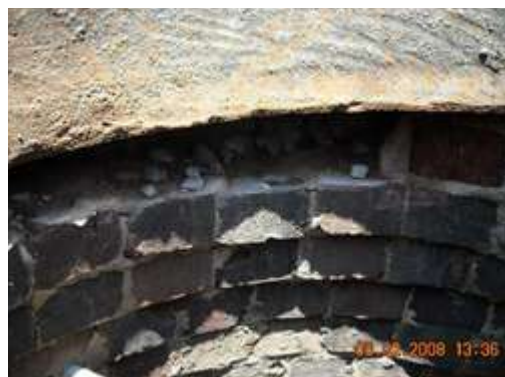
Defect 1

deteriorated corbel bricks

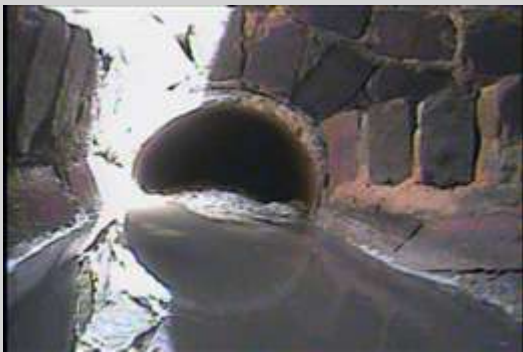
12 O'Clock Outflow

Pipe Height: **8.4** (in.) Rod and Bar (Angled)  
Pipe Material: **Clay** ☐ Pipe Lined  
Invert Depth: **8.10** (ft.) Flow Characteristics: **Slow**  
Deposits: ☐ None ☐ Mud ☒ **Sludge** ☐ Debris ☐ Grease  
Silt Depth: **2** (in.) Deposits Extent: **Light**  
Infiltration: **None** Pipe Seal Cond: **Sound**
